Fractography of Advanced Structural Ceramics: Results From The VAMAS Round Robin Exercise

Jeffrey J. Swab and George Quinn

ARL-TR-656

December 1994

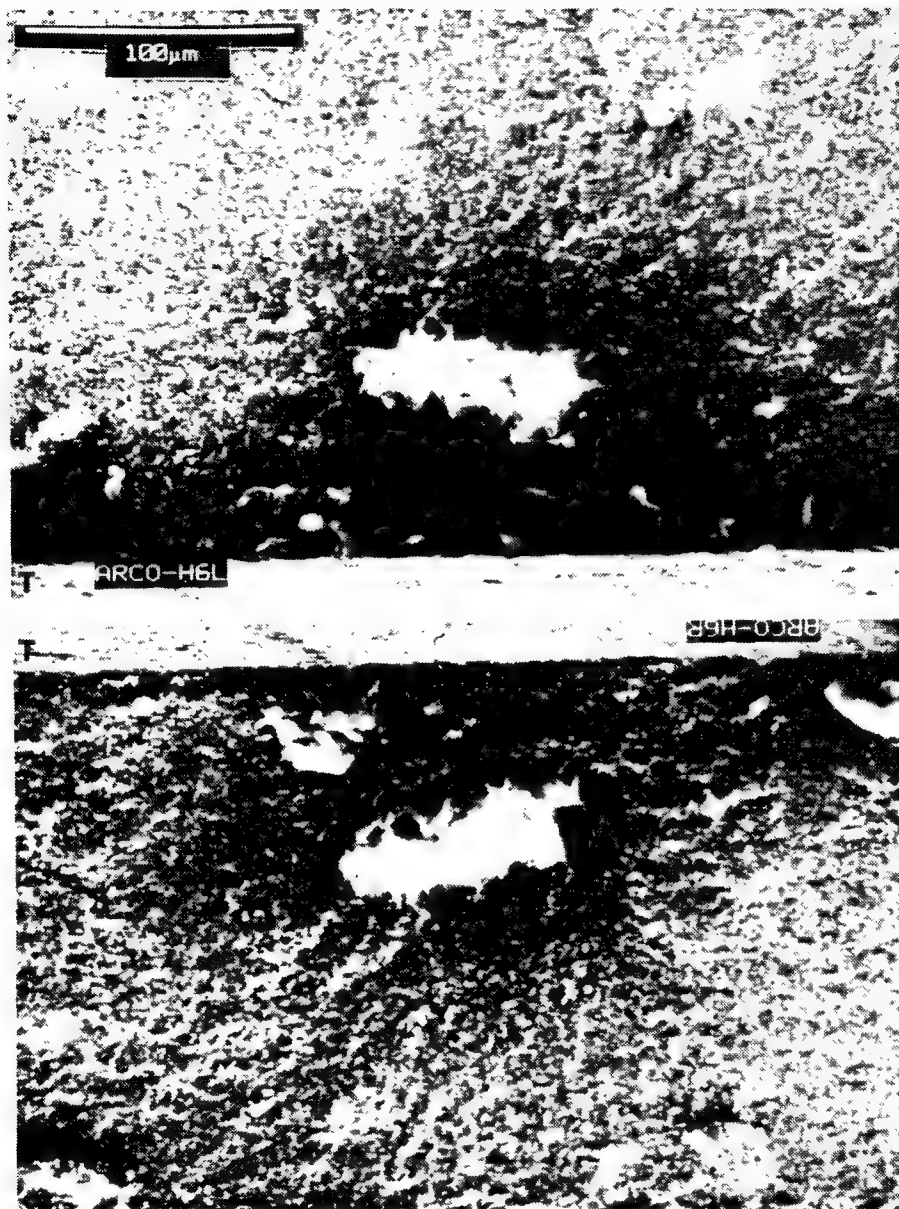
Figure 2.1.1. Example of Large Grains in Specimen 1: Alumina/SiC (whiskers). Mating halves of the primary fracture surface are shown. "T" denotes the tensile surface.

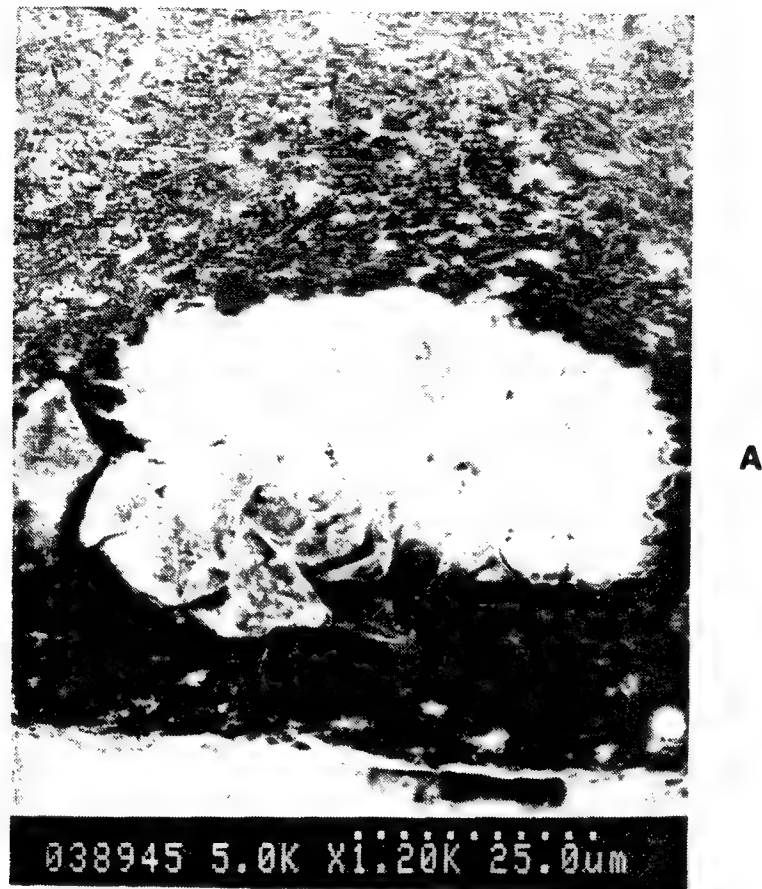
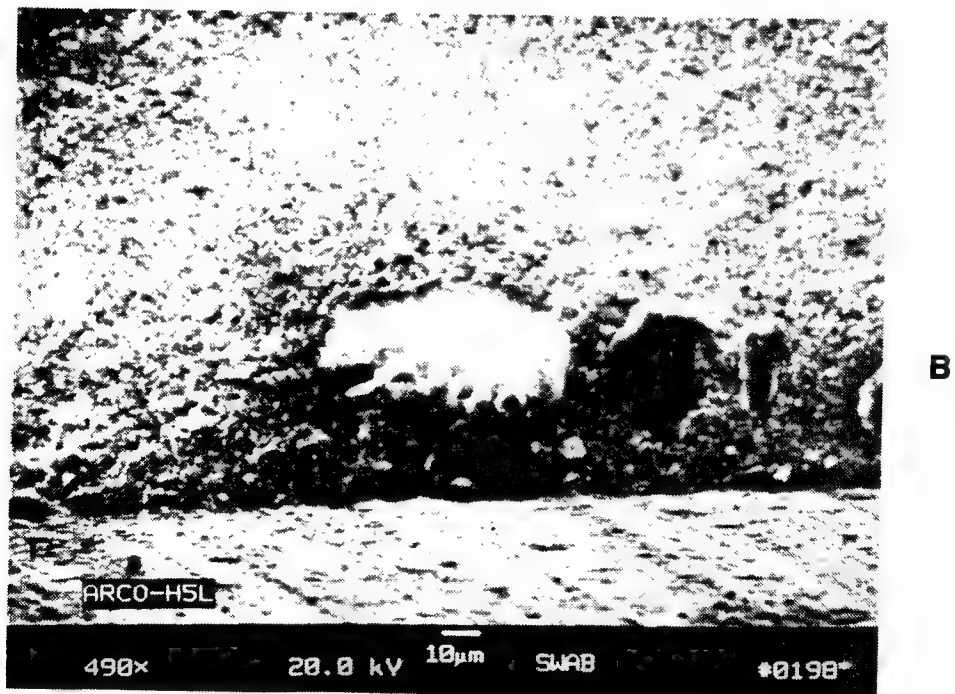
Figure 2.1.2. Photographs of large grain fracture origin in specimen 1 from participant 2 specimen set. A) Participants' photograph. B) Organizers' photograph. "T" denotes the tensile surface in B).

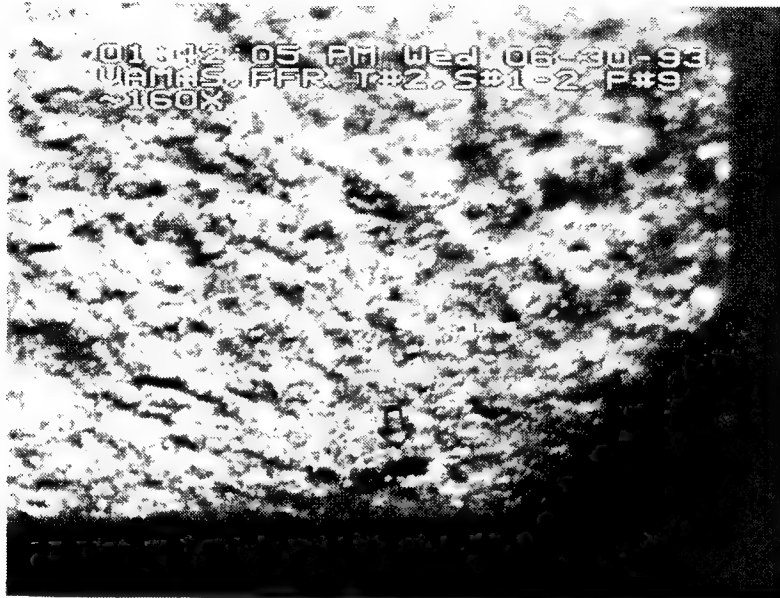
Figure 2.1.3. Optical photograph of alumina grains as the fracture origin in specimen #1. Origin appears as a dark spot when viewed optically. (Arrow added by the organizers.)

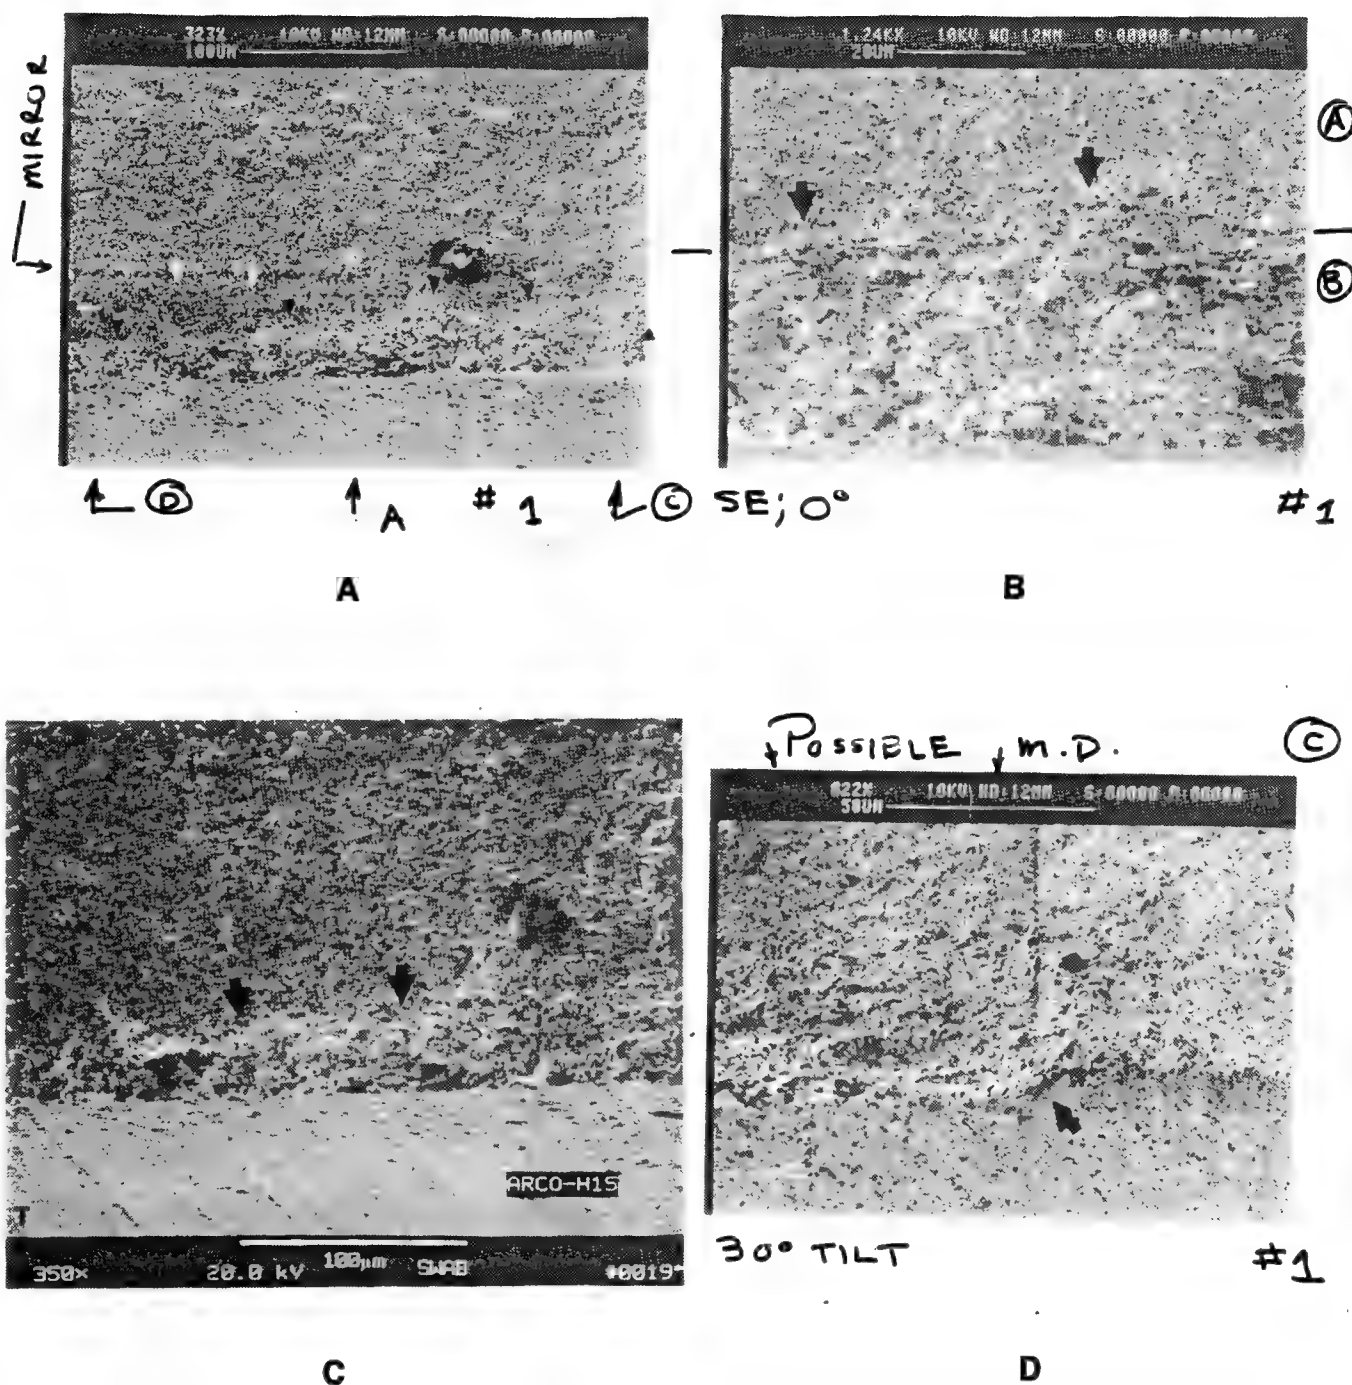
Figure 2.1.4. Photographs of large grain origin in specimen 1 from participant 4. A) and B) are the participants' photographs. Large grains can be seen in B). C) Organizers' photograph. "T" denotes the tensile surface. D) Participants' photograph of the possible machining damage. (Arrows in B and D were added by the organizers. Handwritten notes on A), B) and D) are the participants.)

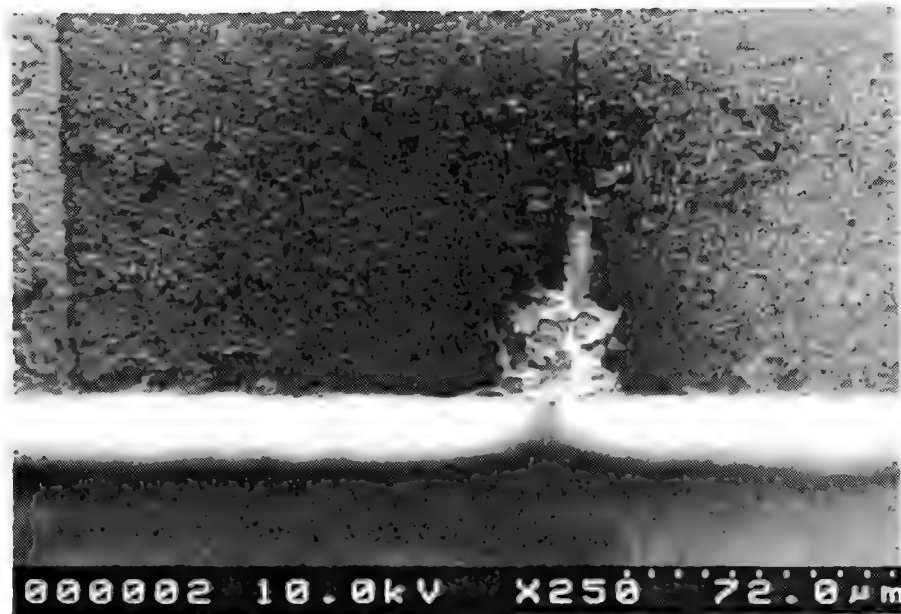
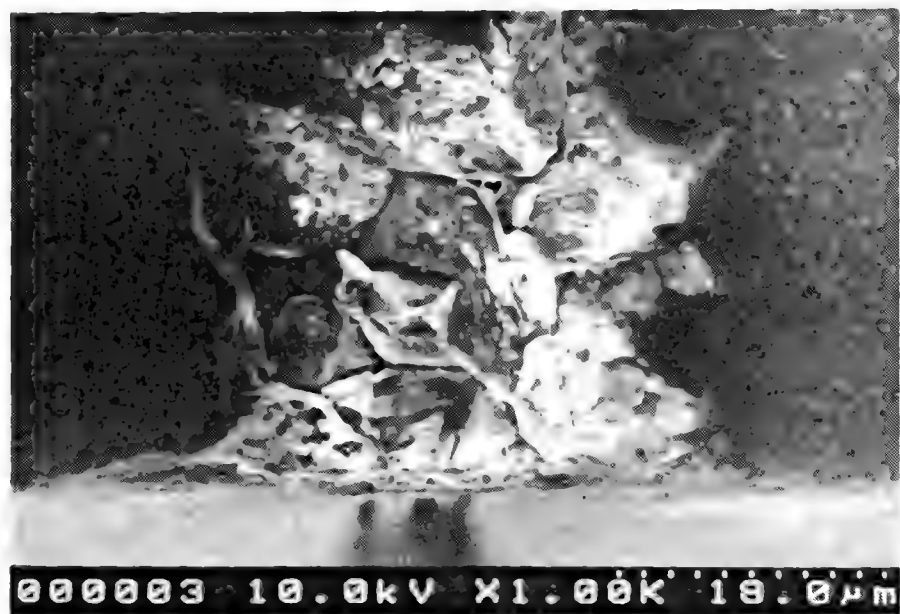
Figure 2.1.5. Two of participant 18's photographs of the origin in specimen 1. The origin is clearly located at the surface.

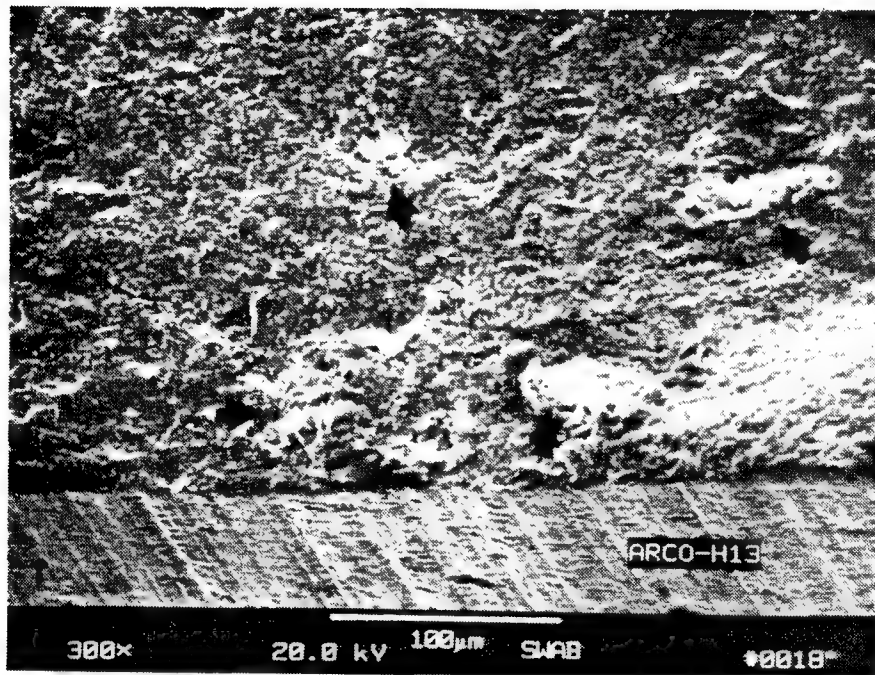
Figure 2.1.6. Organizers' SEM photograph showing several clusters of large alumina grains in specimen 1. "T" denotes the tensile surface.

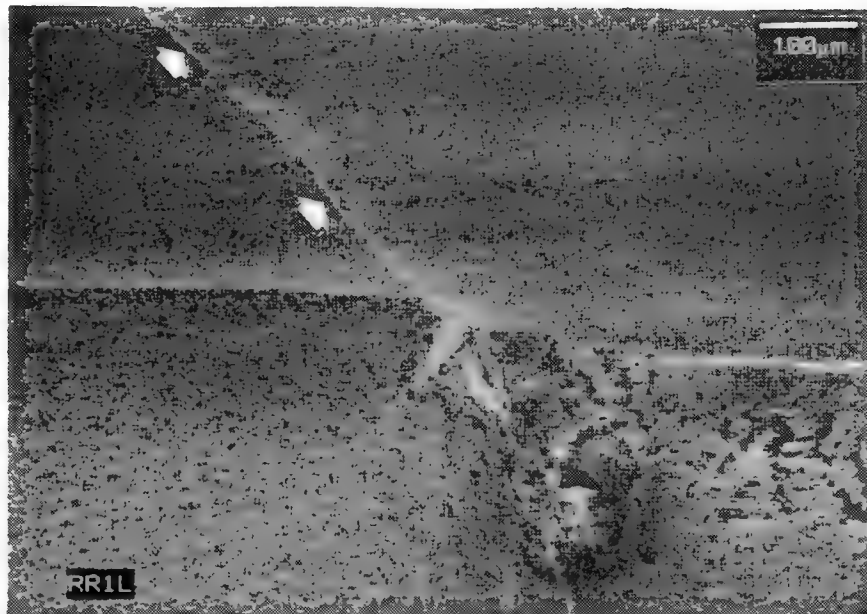
Figure 2.2.1. Example of Handling Damage in Specimen 2: Alumina. "T" denotes the tensile surface.

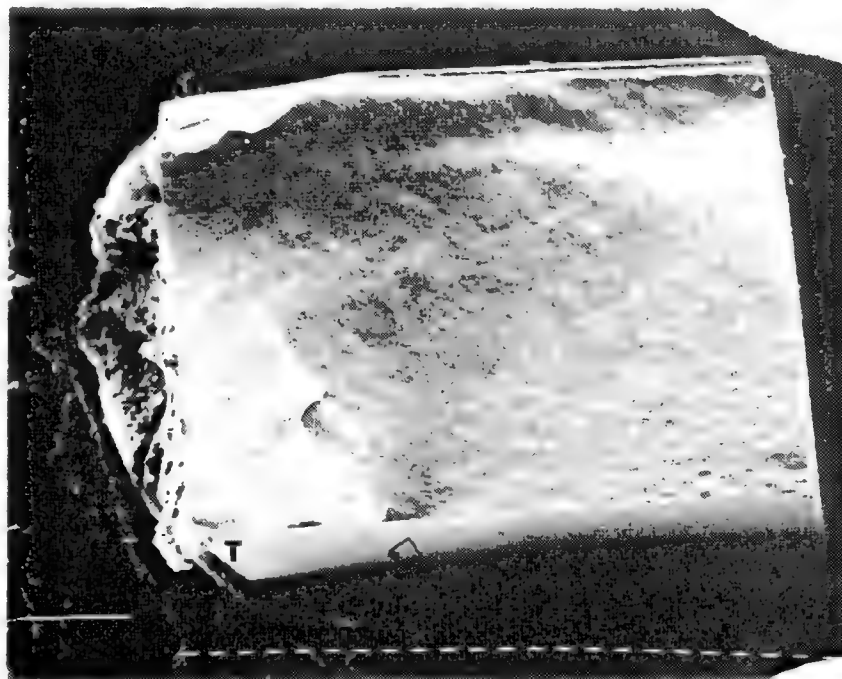
Figure 2.2.2. Participant 16's photograph of one of the mating halves of the primary fracture surface in specimen 2. The arrow was added by the organizers and points out the scratch (HD^S) on the tensile surface (T).

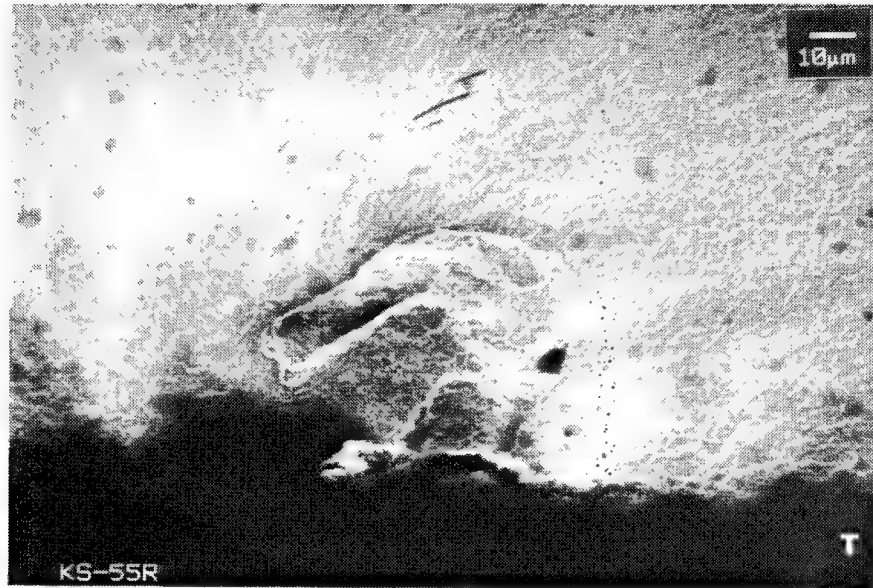
Figure 2.3.1. Example of a Pore in Specimen 3: Zirconia. "T" denotes the tensile surface.

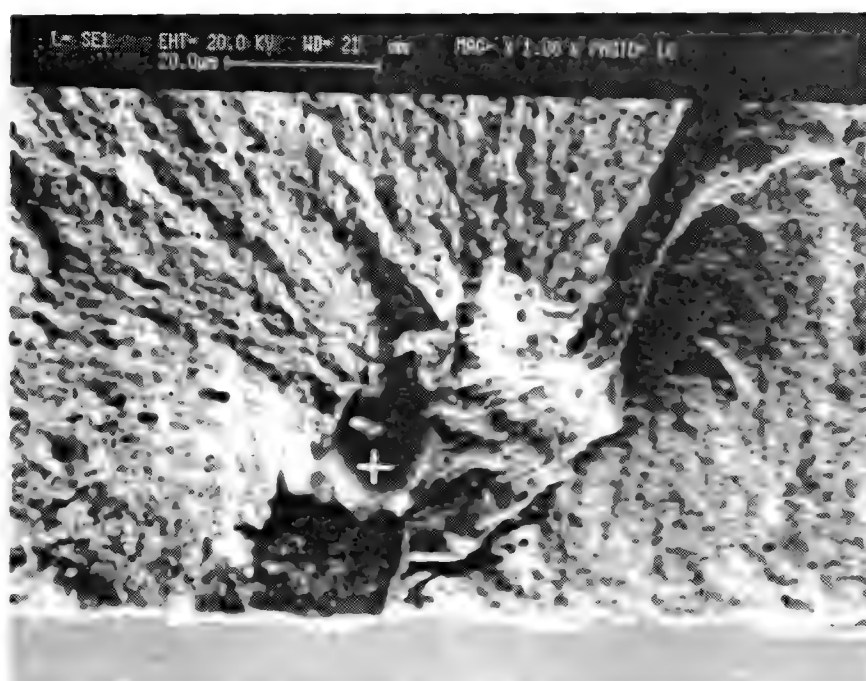
Figure 2.3.2. SEM photographs of the pore in specimen 3 from the set sent to participant 3. A) Organizers' photograph. "T" denotes the tensile surface. B) Participant 3's photograph. "+" indicates the "globule" where EDS was done.

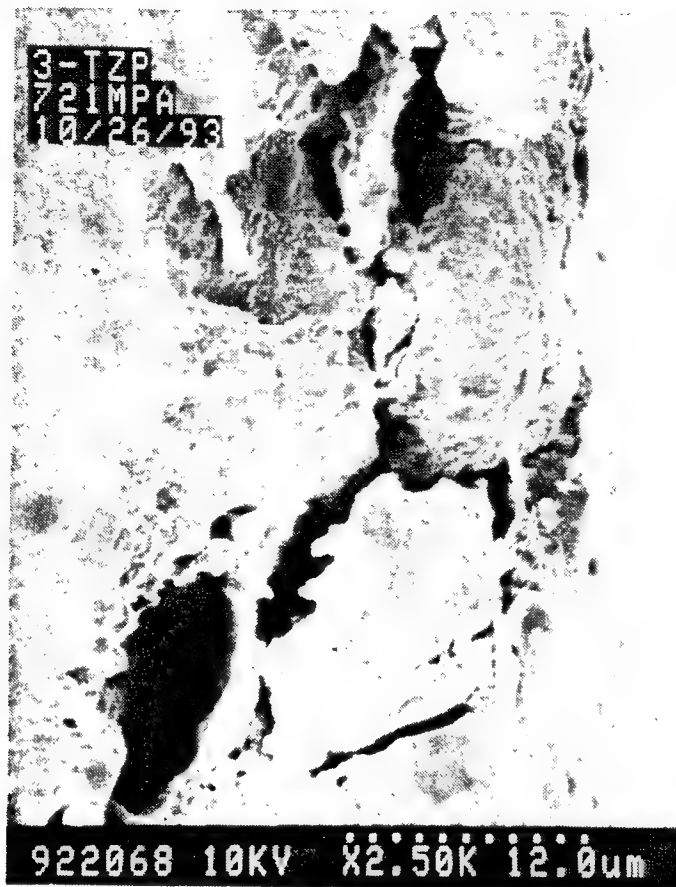
Figure 2.3.3. Participant 5's SEM photograph of the origin in specimen 3. Is this a pore or porous region?

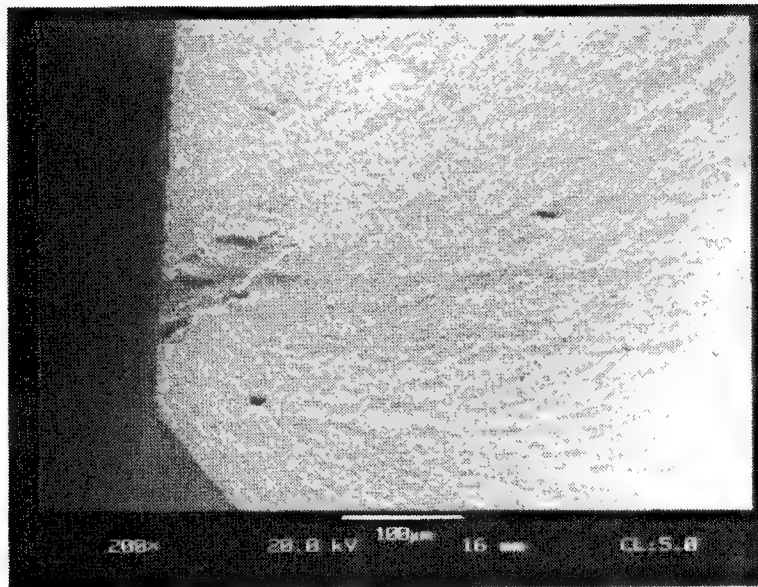
Figure 2.3.5. SEM photograph, from participant 7, of a pore located at the side of the flexure specimen. Appropriate location: Volume (V)*. * located at the side of the specimen approximately 175 μm beneath the tensile surface.

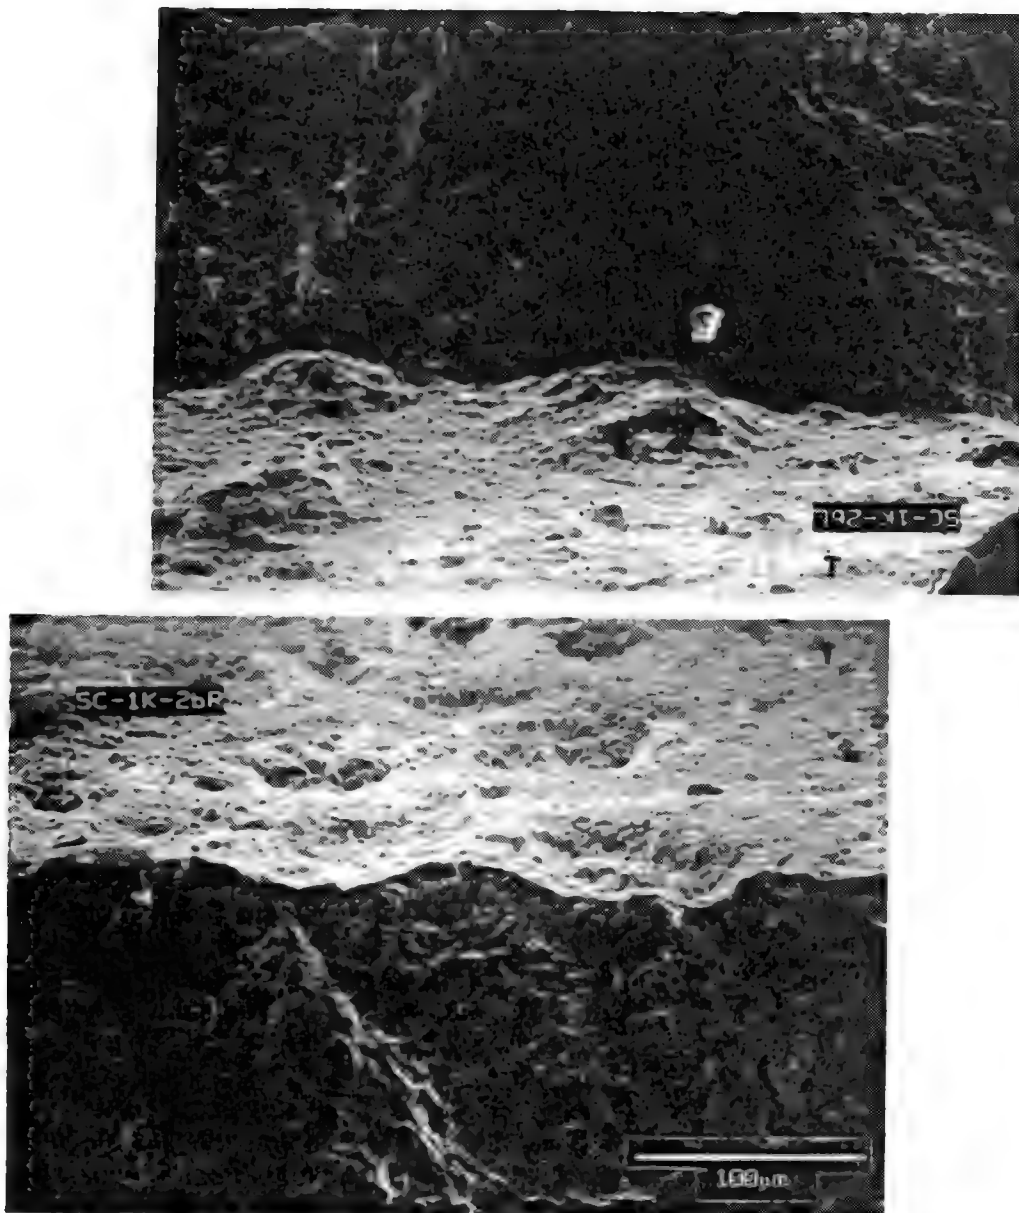
Figure 2.4.1. Example of Pits in Specimen 4: Silicon Carbide. Mating halves of the primary fracture surface are shown. "T" denotes the tensile surface.

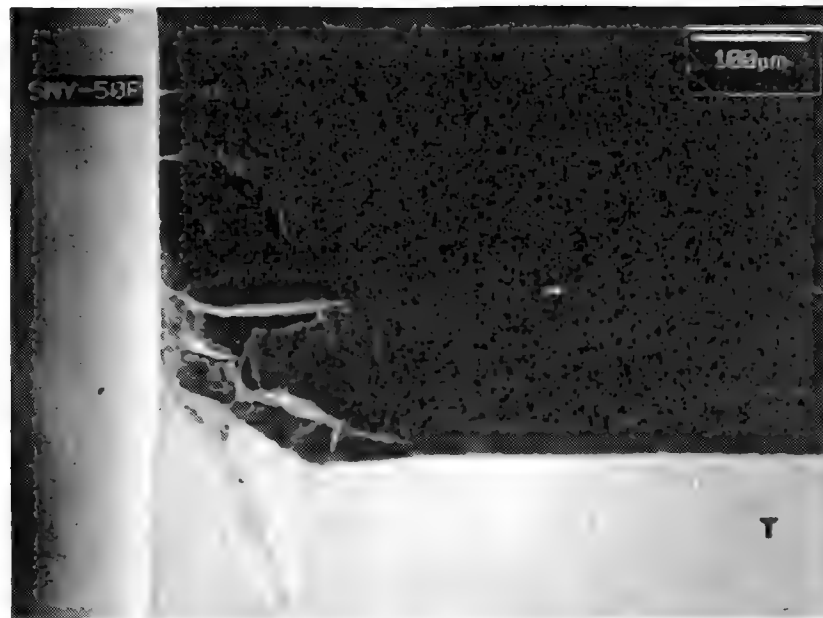
Figure 2.5.1. Example of Machining Damage in Specimen 5: Silicon Nitride. Mating halves of the primary fracture surface are shown. "T" denotes the tensile surface.

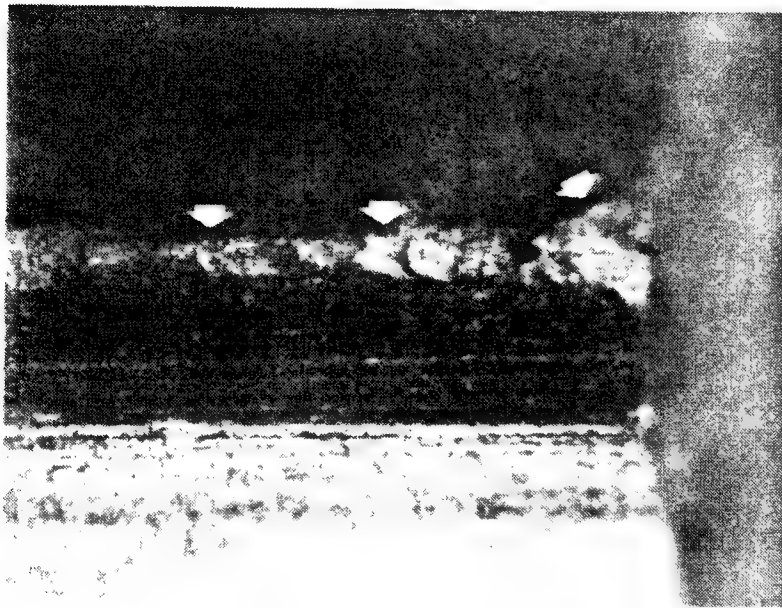
Figure 2.5.2. Optical photograph from participant 4, of machining related chipping on the chamfer of specimen 5. Arrows were added by the organizers.

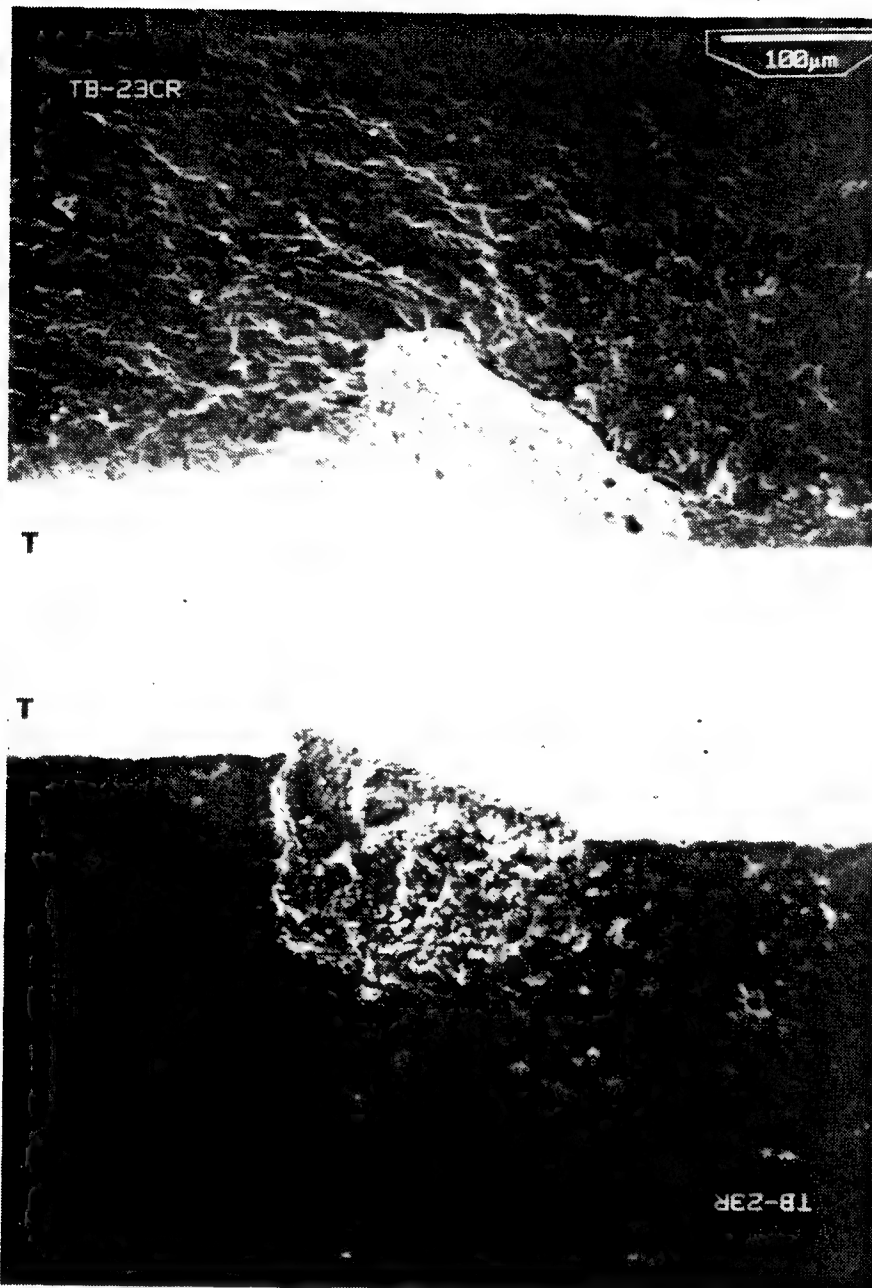
Figure 2.6.1. Example of Porous Seam/Porous Region in Specimen 6: Titanium Diboride. Mating halves of the primary fracture surface are shown. "T" denotes the tensile surface.

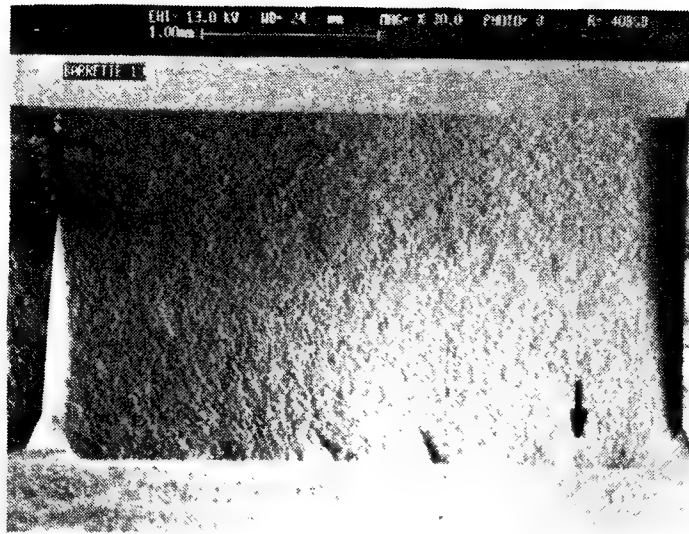
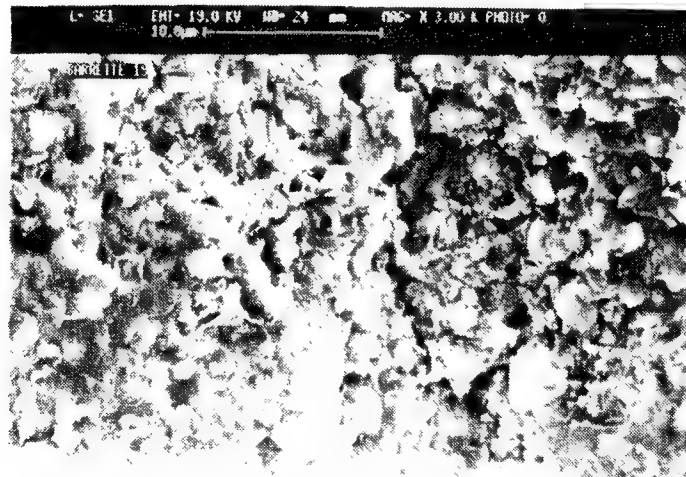
SAMPLE N° 19

Figure 3.6. Example of an origin in a $\text{Si}_3\text{N}_4/\text{TiN}$ specimen. Labeled by participant 10 as a crack.

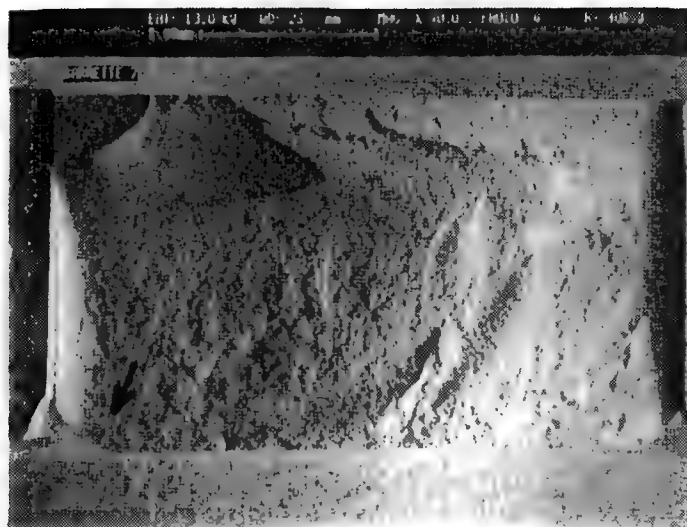
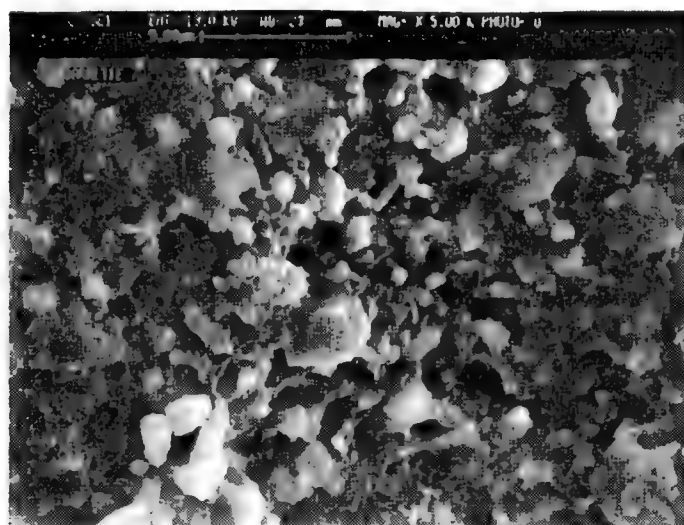
SAMPLE N° 7

Figure 3.7. Example of an origin in a $\text{Si}_3\text{N}_4/\text{TiN}$ specimen. Labeled by participant 10 as a porous region.

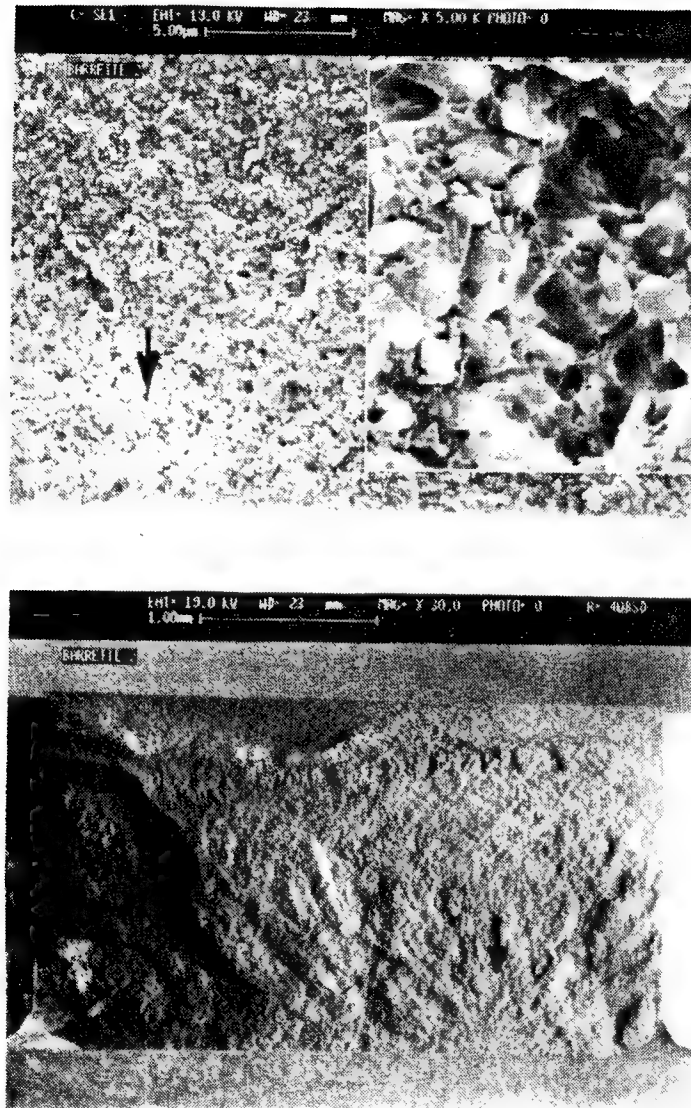
SAMPLE N° 2

Figure 3.8. Fracture origin in specimen 2 for a $\text{Si}_3\text{N}_4/\text{TiN}$ specimen. Labeled by participant 10 as machining damage.
